KNJIGA SAŽETAKA

Stručni skup s međunarodnim sudjelovanjem
Nacionalna i sveučilišna knjižnica
Zagreb, 20. studenoga 2025.

Obnova i prezentacija stropnih oslika u sklopu cjelovite obnove zgrada oštećenih u potresima 2020. – zagrebački primjeri

Restoration and presentation of ceiling paintings within the comprehensive renovation of buildings damaged in the 2020 earthquakes – Zagreb case studies

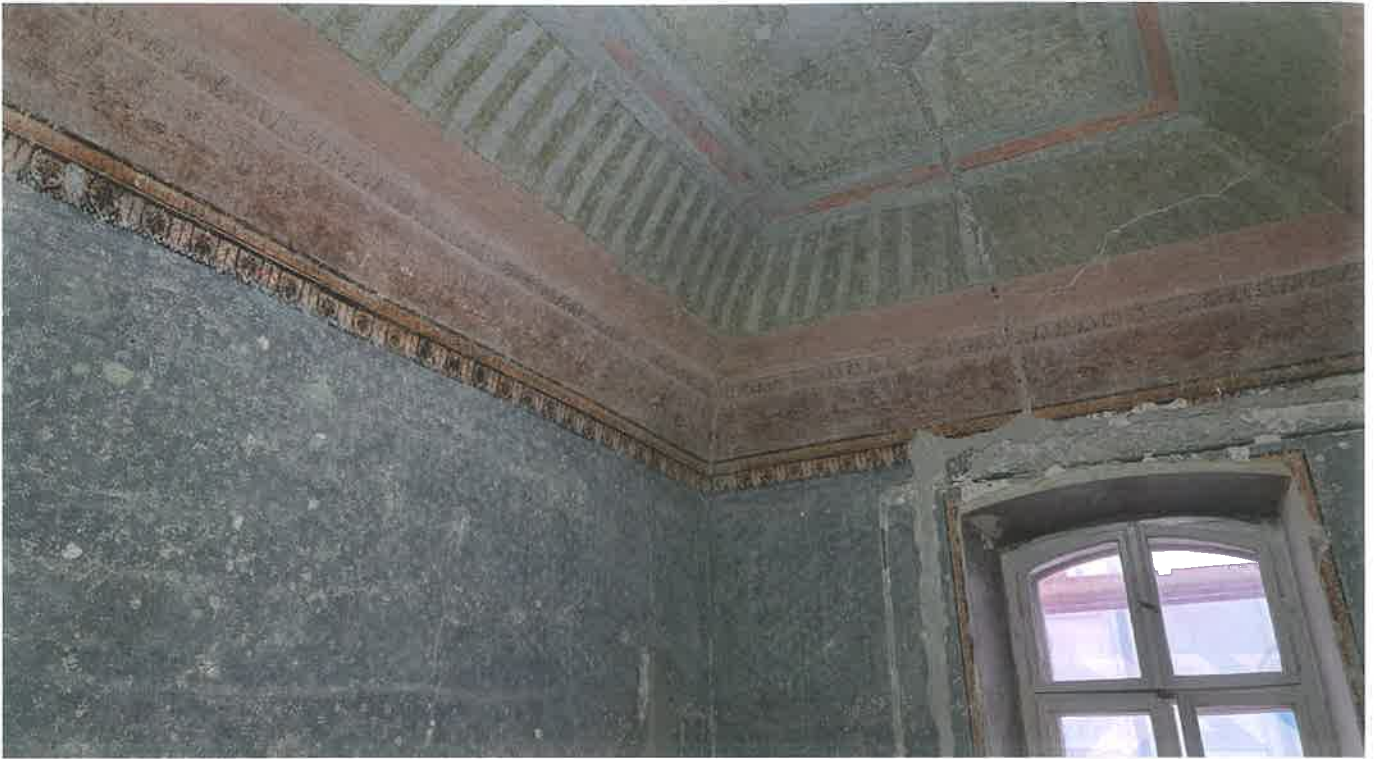
Zagreb, Palača Erdödy Keglević, novotkriveni zidni ostik (snimka: S. Veršić, 2025.)
 Zagreb, Erdödy Keglević Palace, newly discovered wall painting (photo: S. Veršić, 2025)

Tijekom aktualne obnove palače Erdödy – Keglević (Jezuitski trg 2) konzervatorsko-restauratorskim su istraživanjima u većini prostorija, i na prvom katu i u prizemlju, otkriveni oslici na zidovima, svodovima i stropovima. Preliminarnom analizom oslika utvrđeno je da oslici zapadnog dijela kompleksa pripadaju najstarijem sloju, odnosno da su slikani neposredno nakon izgradnje palače, na prijelazu iz 18. u 19. stoljeće. Slikani su u duhu bidermajera, no uz primjenu još nekih slikarskih odlika kasnobaroknoga iluzionizma, pa su s povijesno-umjetničkog aspekta kvalitativno najzanimljivije otkriće. Oslici na stropu, pronađeni u brojnim prostorijama ostaloga dijela kompleksa palače, pripadaju historicističkomu sloju, a oslikani su potkraj 19. stoljeća. U svim se navedenim prostorijama, na drvenim stropnim konstrukcijama izniveliranim trskom, ponavlja vrlo sličan kompozicijski koncept oslika s različito oblikovanim rozetama u središtu te geometriziranim dekorativnim bordurama na rubovima stropova. Restauriranje se izvodi *in situ* i planirana je njihova cjelovita prezentacija.

During the ongoing renovation of the Erdödy–Keglević Palace (Jezuitski trg 2), conservation and restoration research revealed vault, and ceiling paintings in most rooms on both the ground and first floor. A preliminary analysis established that the paintings in the western part of the complex belong to the oldest layer that was painted immediately after the construction of the palace at the turn of the 19th century. They were painted in the Biedermeier style with certain features of late Baroque illusionism making them the most artistically significant discovery. Ceiling paintings discovered in many other rooms of the palace belong to the historicist layer painted in the late 19th century. In all of these rooms, a very similar compositional concept of paintings is repeated on the wooden ceiling structures levelled with reeds, with differently shaped rosettes in the centre and geometric decorative borders on edges. Restoration is being carried out *in situ*, with a full presentation planned.

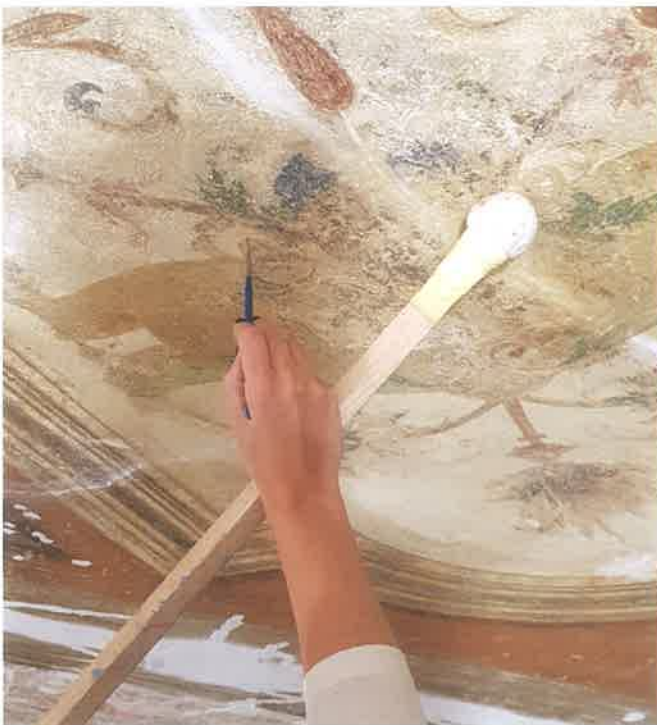
Zagreb, Gornjogradska gimnazija, stropni ostik svečane dvorane tijekom radova (arhiva GZSKP-a, snimka: A. M. Šerić, 2024./2025.)
 Zagreb, Gornjogradska gimnazija high school, ceiling painting of the ceremonial hall during conservation (GZSKP archive, photo: A. M. Šerić, 2024/2025)

Zidovi dvorane su konstrukcijski ojačani, a vrijedni stropni oslik restauriran je i očuvan *in situ*. Cijela površina stropnog oslika je injektirana i stabilizirana te je s gornje strane povezana s drvenom stropnom konstrukcijom da bi se spriječilo daljnje propadanje žbukane podloge. Stare zakrpe od cementne žbuke su uklonjene i zamijenjene novom na bazi vapna. Bojeni sloj je očišćen od naknadnog naliča i soli te je u cijelosti fiksiran i retuširan.

The walls of the hall were structurally reinforced, and the valuable ceiling paintings were restored and preserved *in situ*. The entire surface of the ceiling paintings was injected and stabilized, and it was connected with the wooden ceiling structure from above to prevent further deterioration of the plaster base. Old cement plaster patches were removed and replaced with new lime-based plaster. Salts and layers of overpainting were removed from the painted layer which was then secured and retouched.

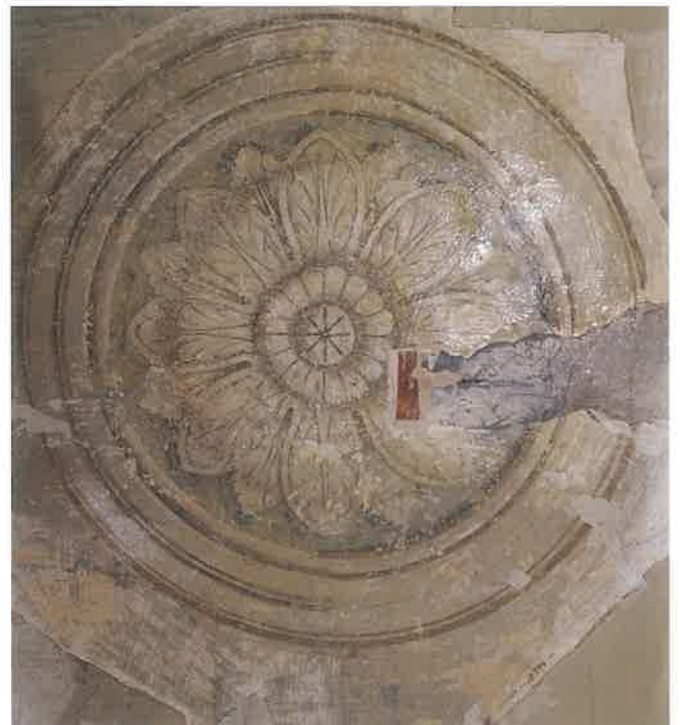
Zagreb, Palača Drašković, Opatička 29. Detalji novootkrivenog ostika (snimka: M. G. Čumbrek, 2024./2025.)
 Zagreb, Drašković Palace, Opatička 29. Details of the newly discovered wall painting (photo: M. G. Čumbrek, 2024/2025.)

U sklopu radova konstrukcijske i cjelovite obnove palače Drašković (Opatička 29 / Demetrova 17) provedena su opsežna konzervatorsko-restauratorska istraživanja kojima je otkriveno više slojeva kvalitetnih dekorativnih i figurativnih zidnih oslika, različitih stilskih karakteristika (kasnobaroknih, barokno-klasicističkih, bidermajerskih) i tehnika izvedbe. Projektom cjelovite obnove predviđeno je restauriranje i prezentiranje najvrjednijih oslika u salonima palače na prvom katu, kao i u pojedinim prostorijama drugog kata i prizemlja. Zbog lošeg stanja stropa (žbuka na trstici pričvršćena na drvene grede) i konstruktivnih radova ojačanja, oslik je dokumentiran i 3D skeniran, a dijelovi tehnikom *stacco a masello* odvojeni s grednika i pohranjeni, da bi se mogli vratiti na izvornu poziciju i prezentirati.

As part of the structural and comprehensive renovation of the Drašković Palace (Opatička 29 / Demetrova 17), extensive conservation and restoration research revealed several layers of high-quality decorative and figurative wall paintings of different stylistic characteristics (late Baroque, Baroque-classicist, Biedermeier) and techniques. The comprehensive renovation project foresees the restoration and presentation of the most valuable paintings in the salons on the first floor, as well as in selected rooms on the second and ground floor. Due to the poor condition of the ceiling (plaster on reed attached to wooden beams) and structural reinforcement, the paintings were documented and 3D-scanned. Parts of the ceiling were detached using the *stacco a massello* technique and stored so that they may later be returned to their original position and presented.

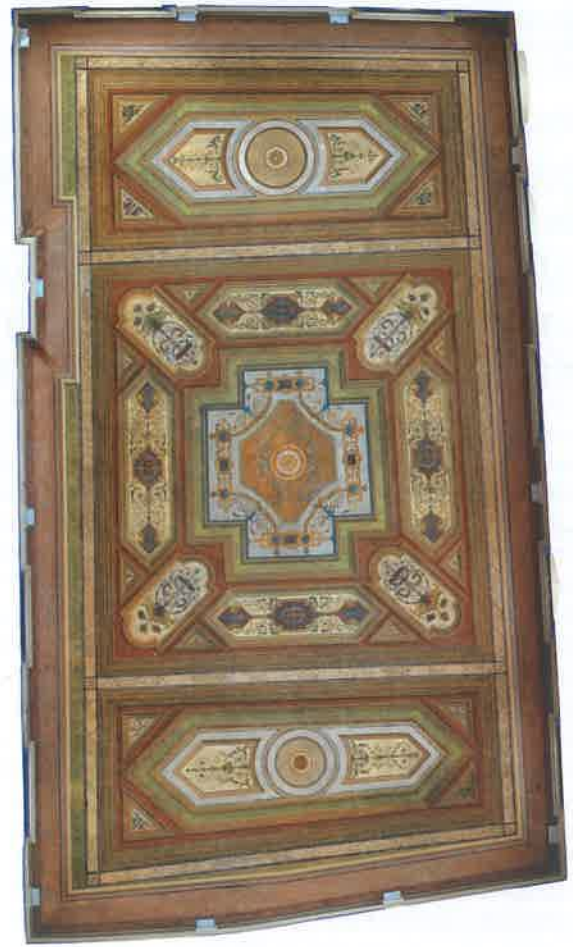
Zagreb, Gornjogradska gimnazija. Strop svečane dvorane prije i nakon radova (ortofoto snimka: Koto d.o.o., 2024./2025.)

Zagreb, Gornjogradska gimnazija high school. Ceiling of the ceremonial hall before and after conservation (orthophoto: Koto d.o.o., 2024/2025)
